526 – Post-Implementation Report

Community:	Isla Popa II (Sandubidi)
Country:	Panama
Chapter:	Rensselaer Polytechnic Institute (EWB-RPI)
Project ID(s):	8801
Submittal Date:	February 21, 2016
Dates Traveled:	January 4th - January 13th 2016
Authors:	Kyra Dauwalder, Tim Andrews, Mike Kubista,
	Elizabeth Kwon, Frank Sokolowski, Elisabeth Ryan,
	Joe Saulsbery, Matt Tice, Adam Ney, Patrick Murphy,
	Ariel Walter, Noa Davis, Megan Kennedy, Jonathon
	Blumers

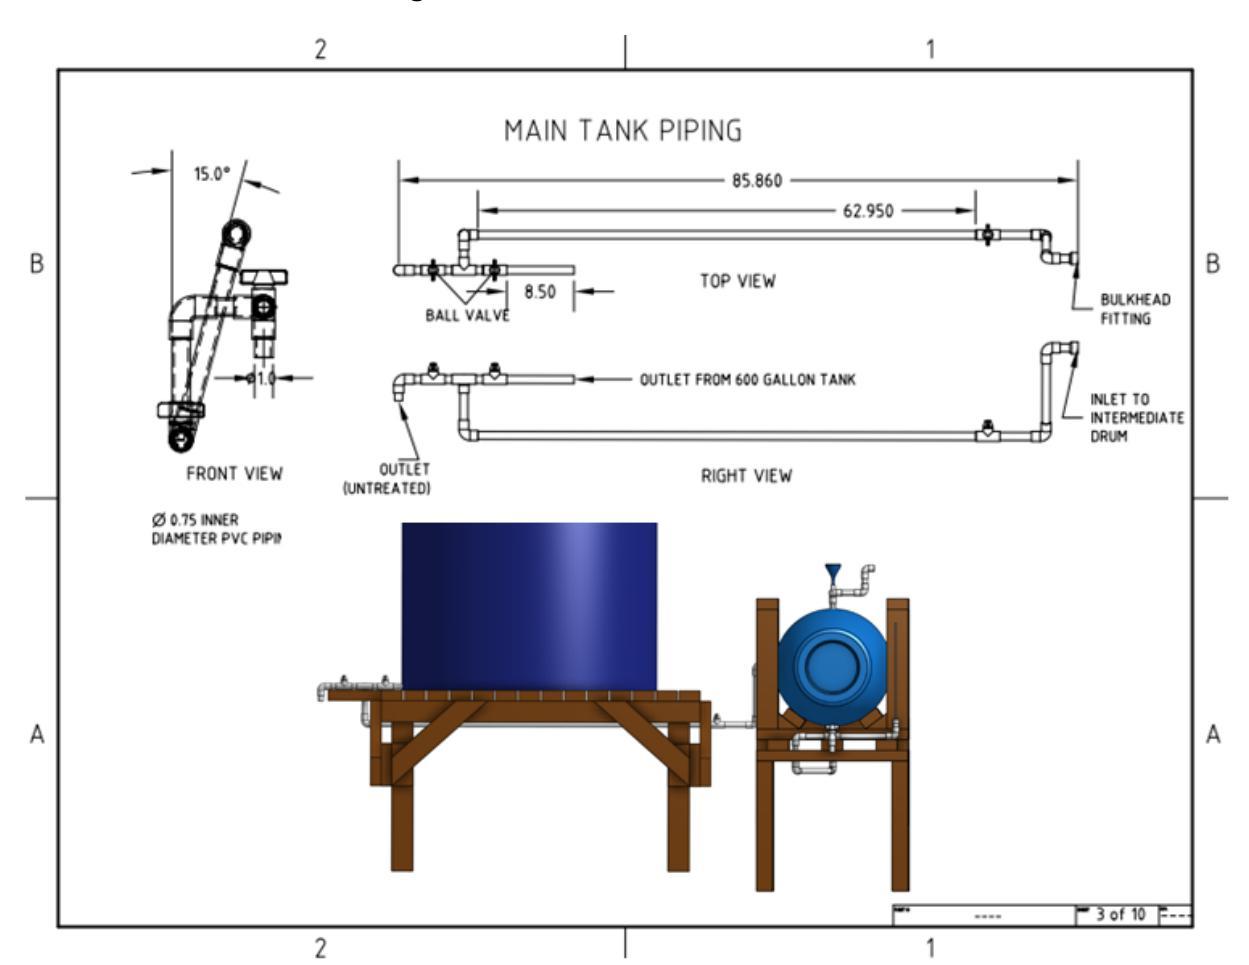
Figure 3.5.1 – As-built drawing of the PVC piping from the main 600-gallon tank to the intermediate drum. The piping runs underneath the 600-gallon tank stand. Also note the CAD rendering on the bottom; the midpoint the horizontal drum height is at the same altitude as the bottom of the main tank.

In order to access the water in the drum and transfer the water from the main tank to the drum, 3 / 4 inch schedule 40 PVC piping was used (Figure 3.5.1). The exit from the main tank was converted from a 1 / 2 inch PVC pipe to the 3 / 4 inch pipe, and a shutoff valve was connected to allow all flow out of the main tank to be stopped, a useful feature if repairs need to be made. A T-fitting was then connected to the piping. One part of the T-fitting traveled to the chlorine drum, while the other, supported by a plank of wood attached to the main tank stand (Figure 3.5.2), provided an access point controlled by a second valve, allowing water to be drawn directly from the main tank. On the path to the drum, the piping passed under the main tank stand and was secured to the bottom of the stand with galvanized brackets. After passing under the stand, a valve was connected which controlled the flow of water into the drum from the main tank (Figure 3.5.1). Opening this valve would fill the drum with water from the main tank. The piping was then connected to a bulkhead fitting attached to the outer circumference of

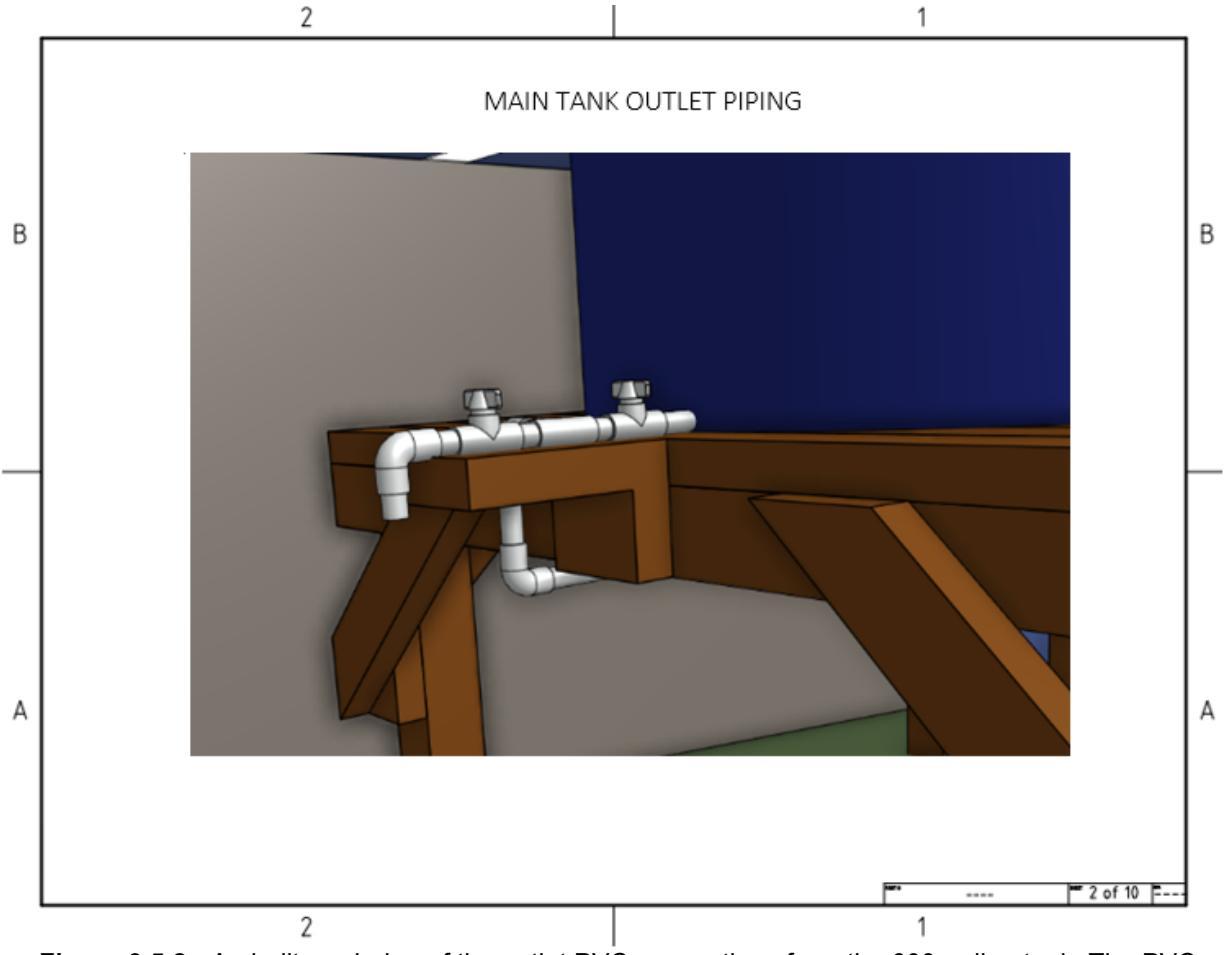
Figure 3.5.2 - As-built rendering of the outlet PVC connections from the 600-gallon tank. The PVC running underneath connects to the 40-gallon drum. A valve at the end of this connection controls flow into the drum. The valve closest to the tank allows for water flow to be shut off for any necessary repairs. The valve farther from the tank allows users to direct access to the stored water in the 600-gallon tank, bypassing the intermediate 40-gallon drum if for any reason it becomes damaged.

In the piping connecting the main tank to the intermediate drum, an access valve off of a T-connection was added before the valve that controlled inflow to the intermediate storage drum. This valve allows direct access of water stored in the main tank, enabling users to bypass the intermediate drum if desired (Figure 3.5.1-2). This feature was added to the system because the team realized that the community depended heavily on the water collected in the two main rainwater storage tanks. In the event that something caused the intermediate treatment drum and treatment system to become inoperable, this should not prevent the community from being able to access the water stored in the main tanks. This access point was added as a precaution to make sure the community would always have access to the large volumes of water stored in the main tanks in the event the additions constructed on this trip fail.

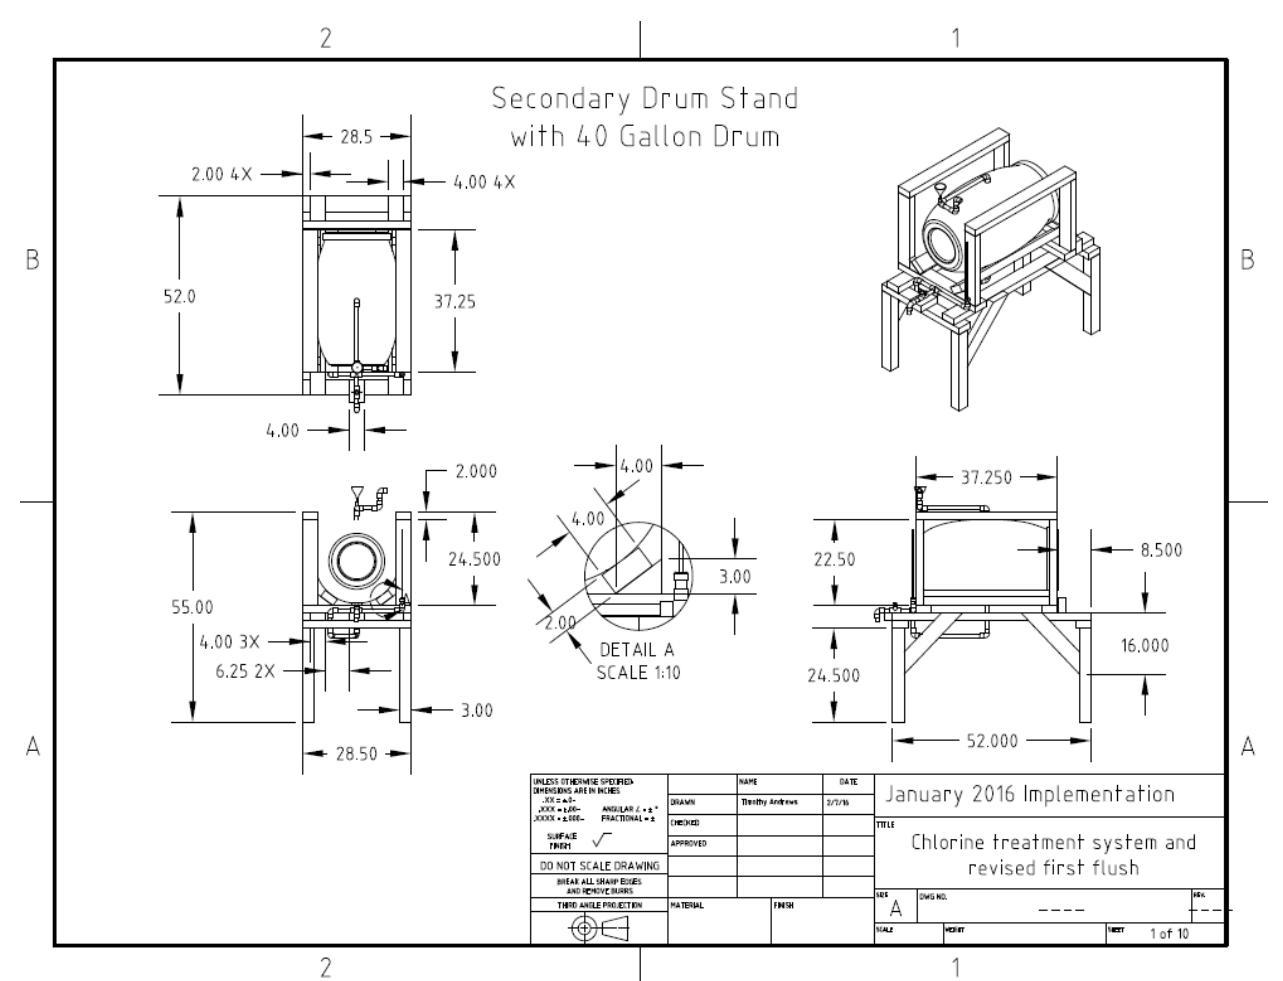
Figure 3.5.3 - As-built drawing of the drum stand for the intermediate 40-gallon drum.

The drum stand consisted of two main parts: the drum cradle with the long axis and the supporting structure. The drum cradle refers to the beams used to support the 40-gallon drum and surrounding corrugated aluminum. The supporting structure carries the drum cradle and includes the legs of the stand (Figure 3.5.3).

The 40-gallon drum was mounted in the drum cradle with the long axis horizontal. In this position, it was supported by two longitudinal beams, which were angled at 45 degrees so that the 4 inch wide surface was contacting the body of the barrel. These two beams were positioned about 6 inches apart and prevented the drum from rolling in addition to bearing the load of the drum. The plane made by the face of the supporting beam is approximately tangent to the surface of the drum at the point of contact. In this way, when the drum flexes under loading, the load will be distributed over a large surface area, reducing stresses on the drum (Figure 3.5.3).

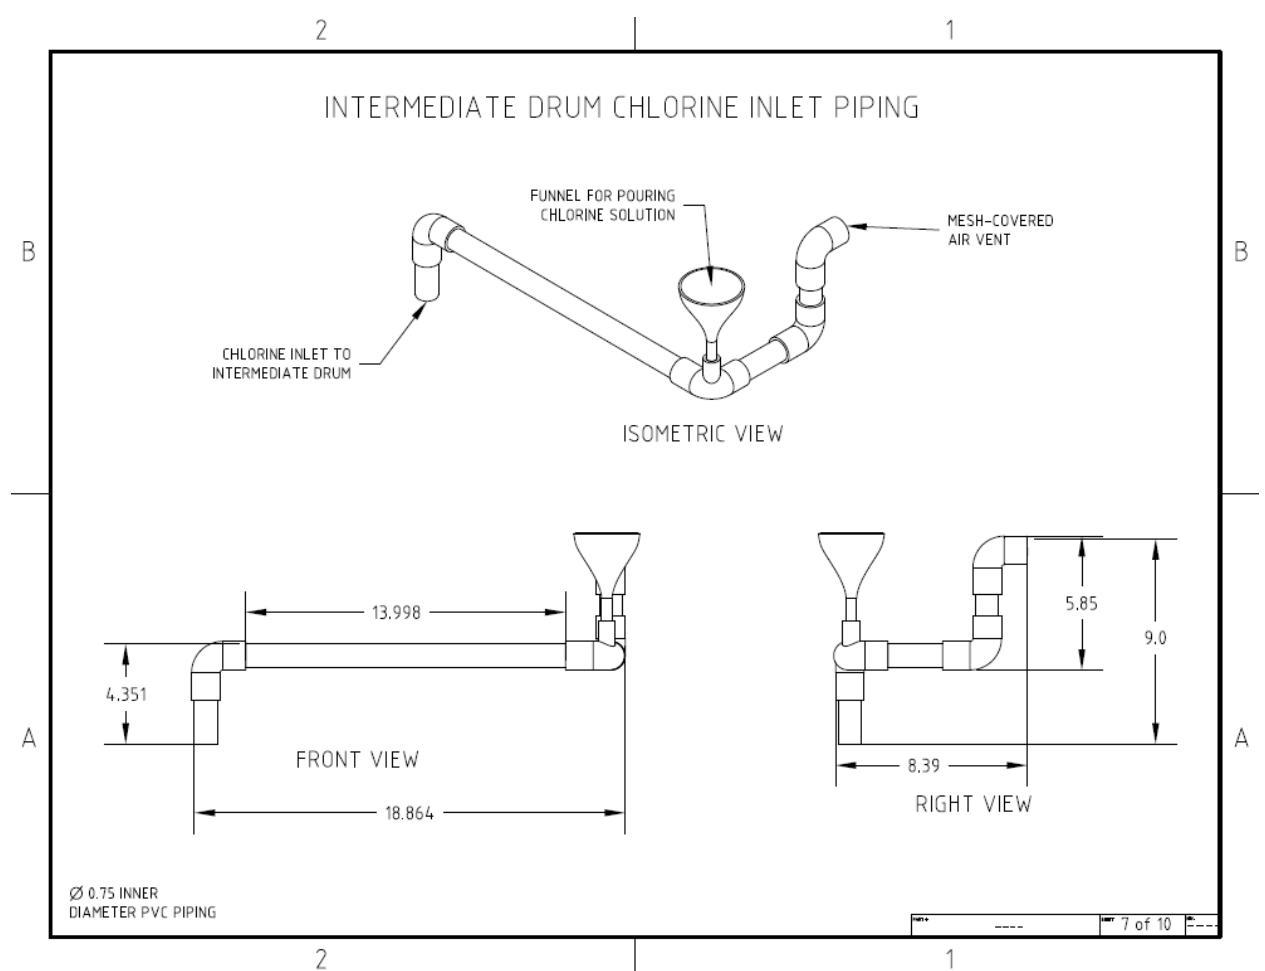
Figure 3.5.4 - As-built drawing of the PVC air vent and chlorine application site for the intermediate drum.

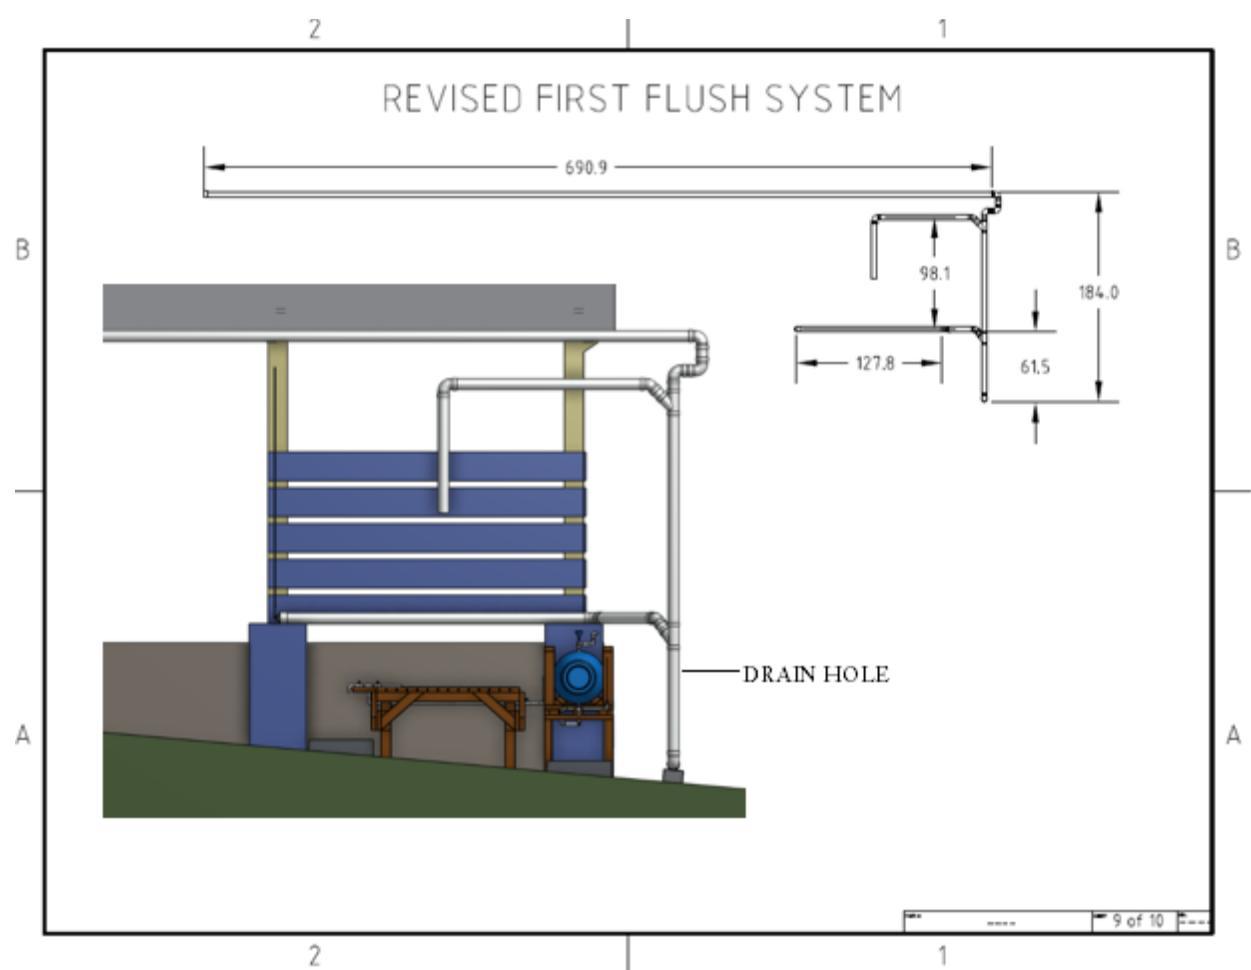
Figure 3.5.5 - As-built rendering of modified first flush system. The original exit to the right of the drum stand is capped. Water flow continues through the elevated PVC along the pavilion concrete support footings and where water now exits at the end.

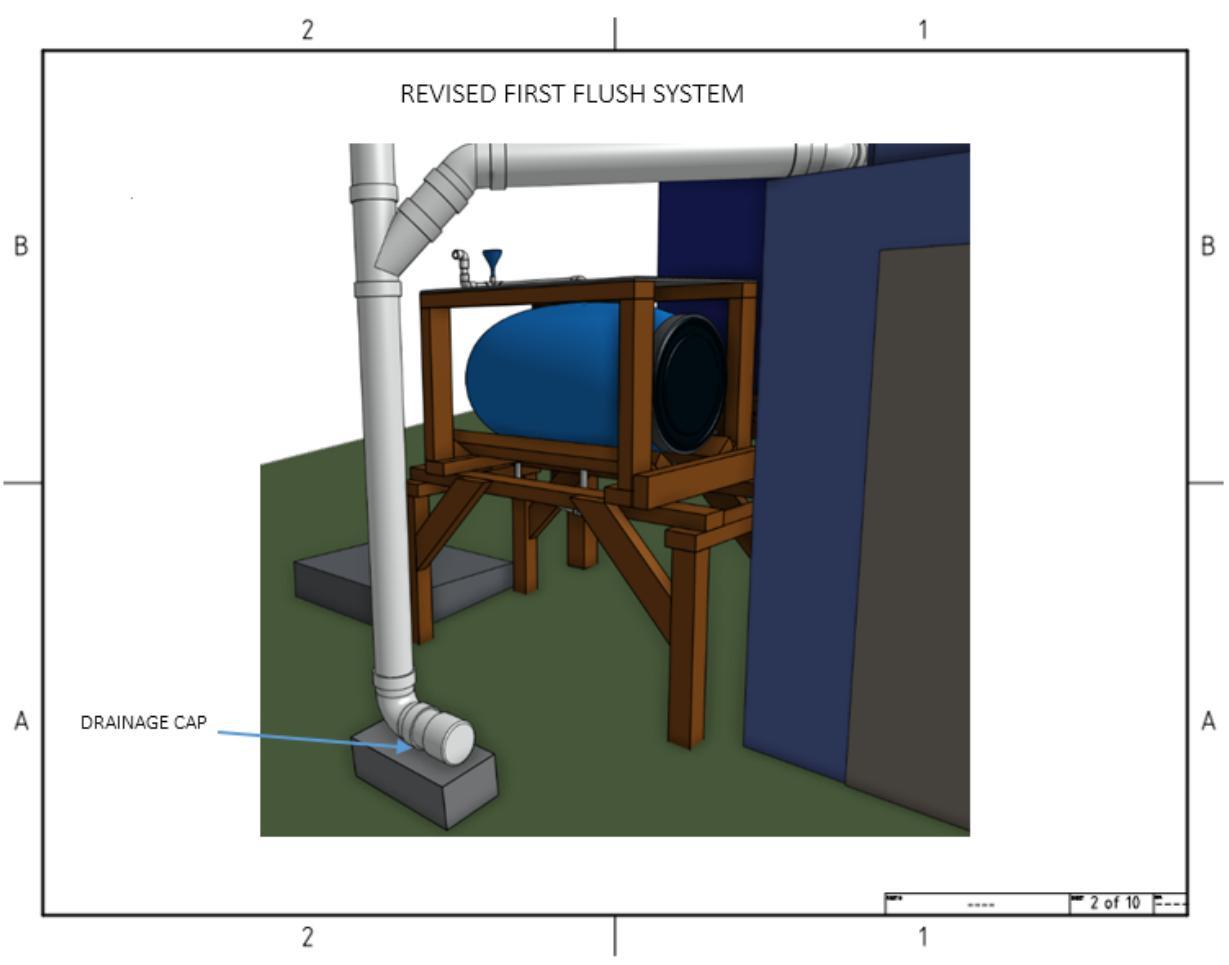
Figure 3.5.6 - As-built image of modified first flush system and added drainage cap to the original water exit location.

Once the construction of the repaired first flush system was complete, the members of the water board were instructed to actively check every few days if leaves had blocked the exit and clogged the steady drainage of water. They also were told to uncap the bottom of the system at the old drainage location as often as remembered to avoid water building up. (Figure 3.5.6)

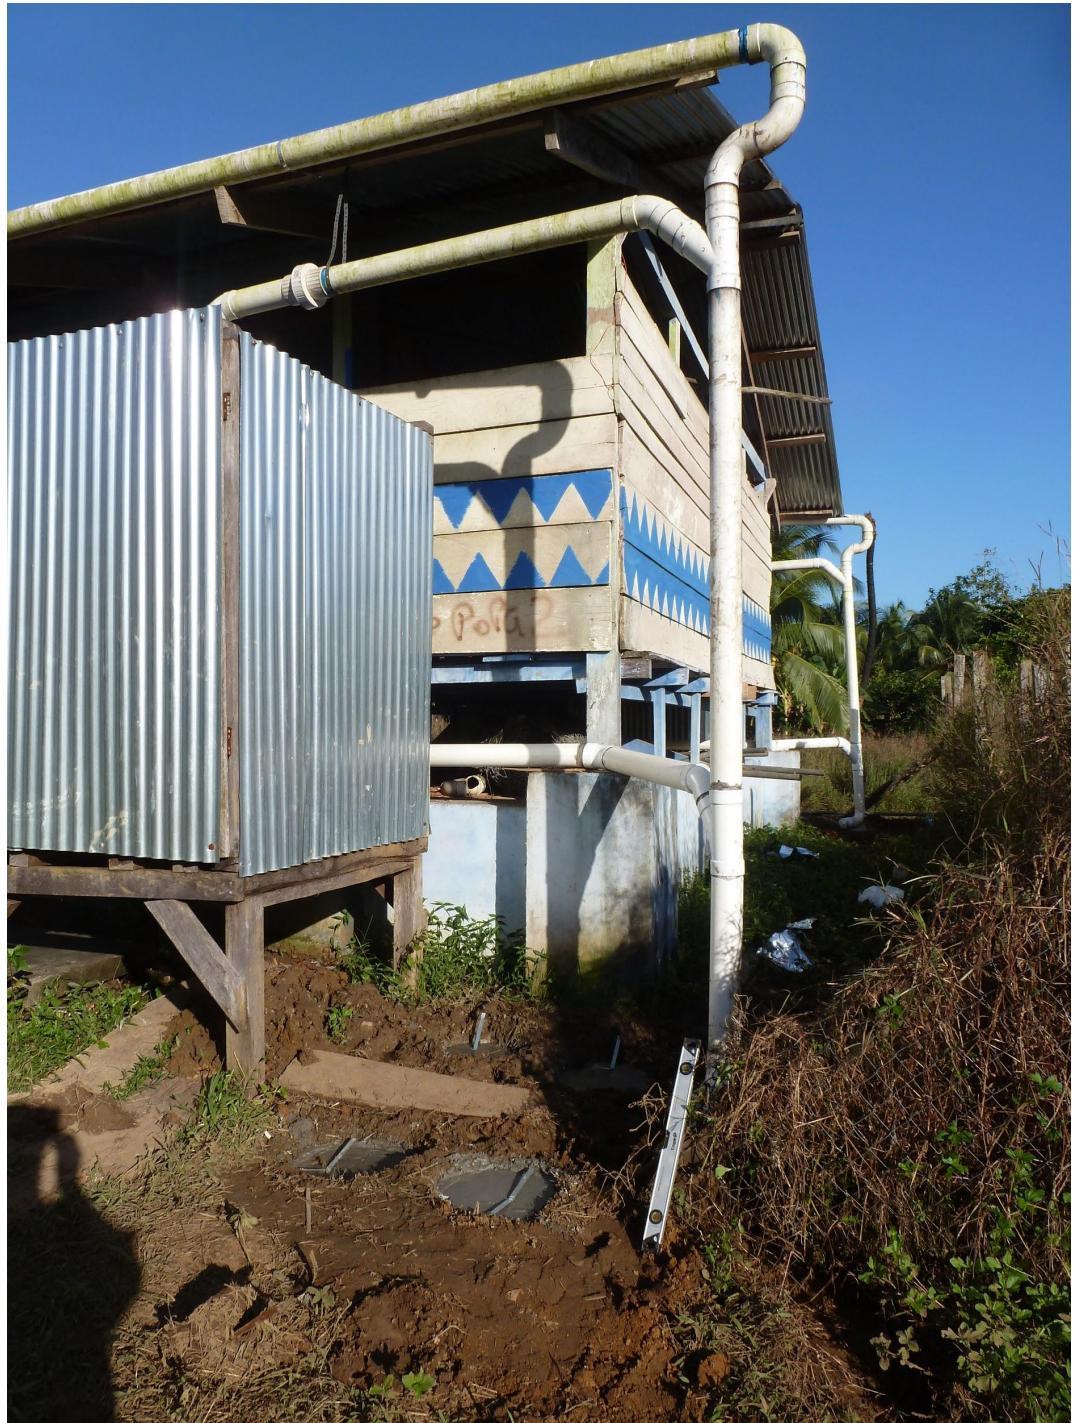
Figure 4.1 - This picture shows the concrete-filled supports for the chlorination tank stand on the landside of the community pavilion.

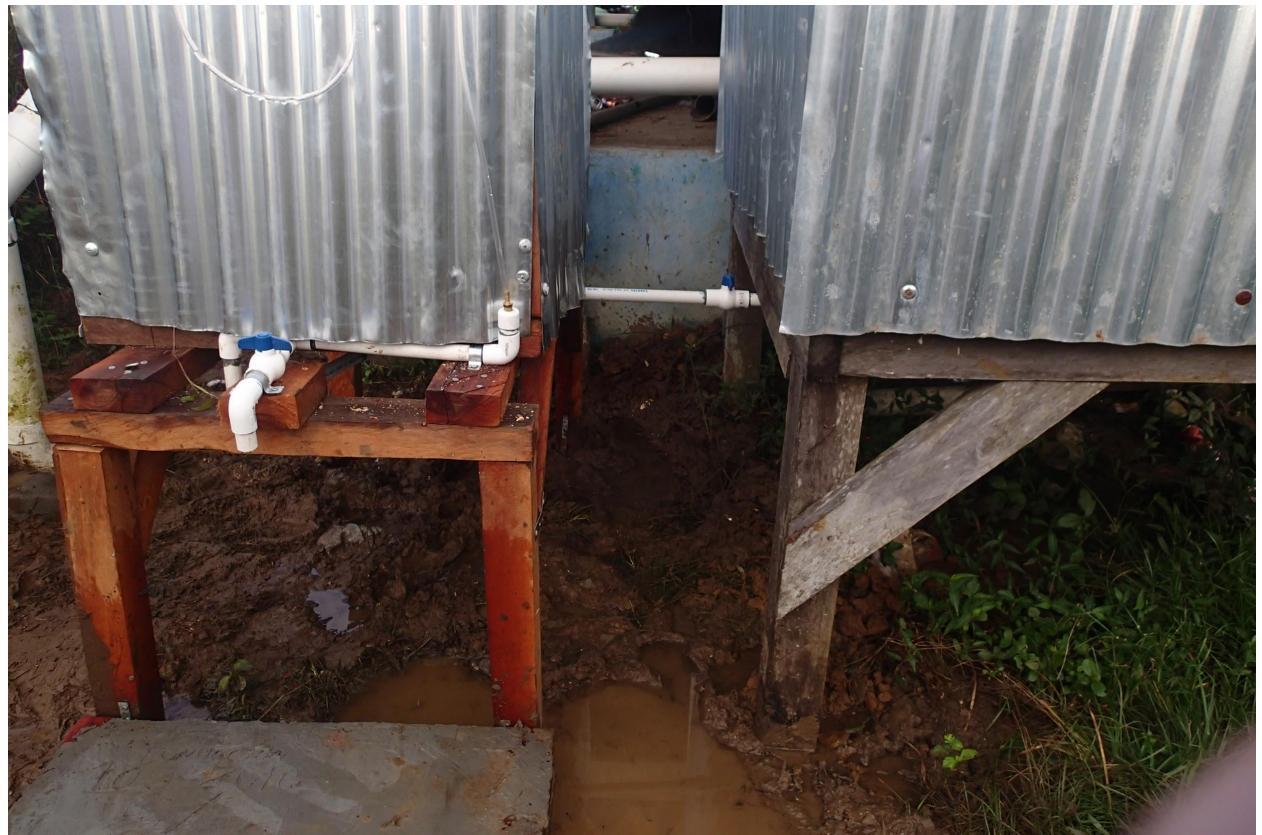
Figure 4.5 - The additional ball valve and connection to the 40-gallon drum are attached to the 600-gallon tank spigot.

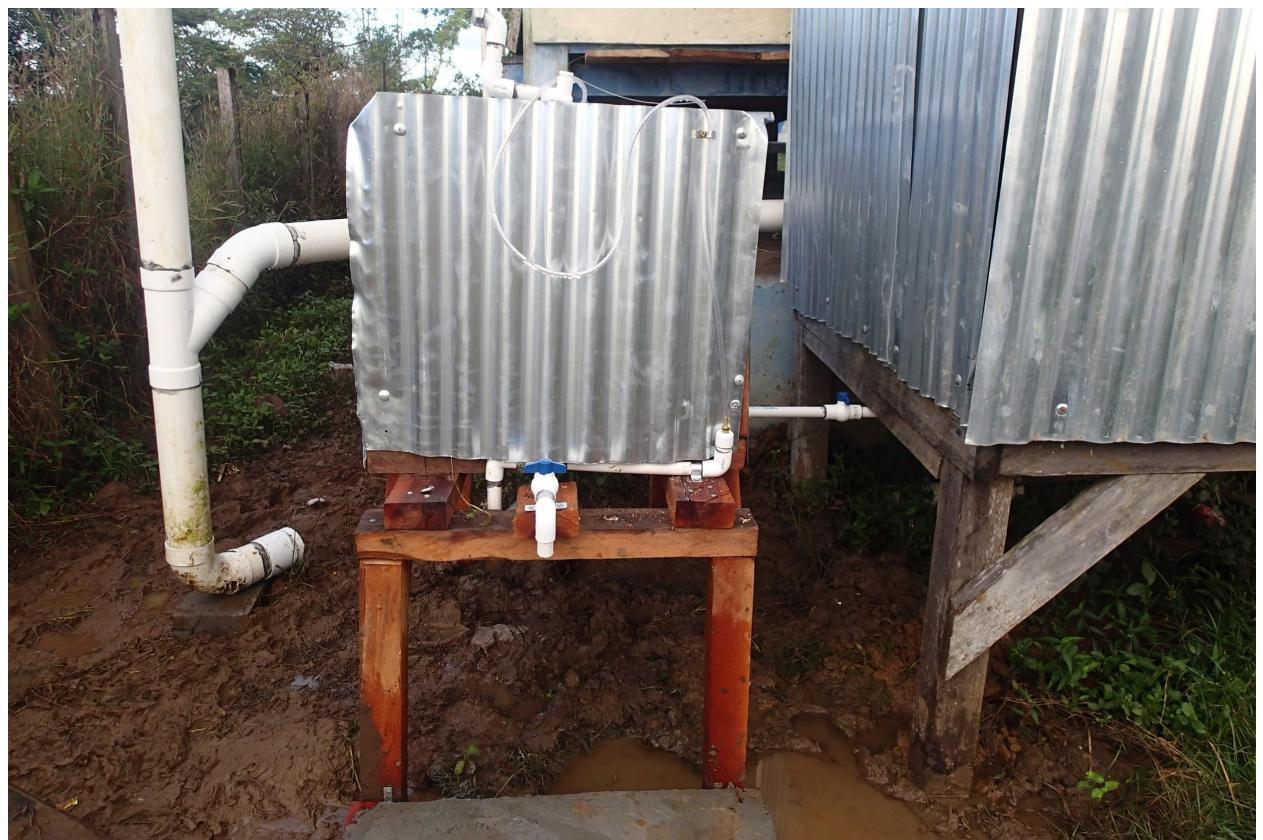
Figure 4.6 - The connection PVC pipe went under the 600-gallon tank, feeding into the 40-gallon drum from the bottom.
