526 – Post-Implementation Report

Community:	Isla Popa II (Sandubidi)
Country:	Panama
Chapter:	Rensselaer Polytechnic Institute (EWB-RPI)
Project ID(s):	8801
Submittal Date:	February 21, 2016
Dates Traveled:	January 4th - January 13th 2016
Authors:	Kyra Dauwalder, Tim Andrews, Mike Kubista,
	Elizabeth Kwon, Frank Sokolowski, Elisabeth Ryan,
	Joe Saulsbery, Matt Tice, Adam Ney, Patrick Murphy,
	Ariel Walter, Noa Davis, Megan Kennedy, Jonathon
	Blumers

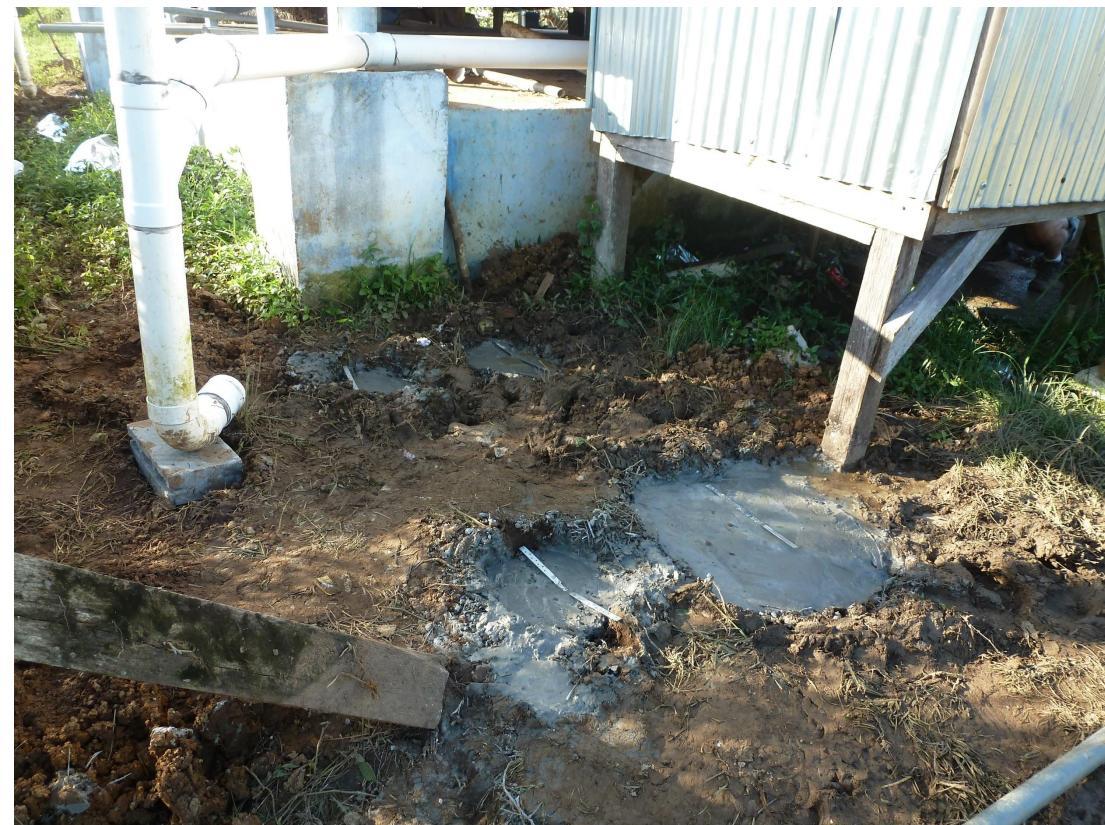
Figure 4.1 - This picture shows the concrete-filled supports for the chlorination tank stand on the landside of the community pavilion.

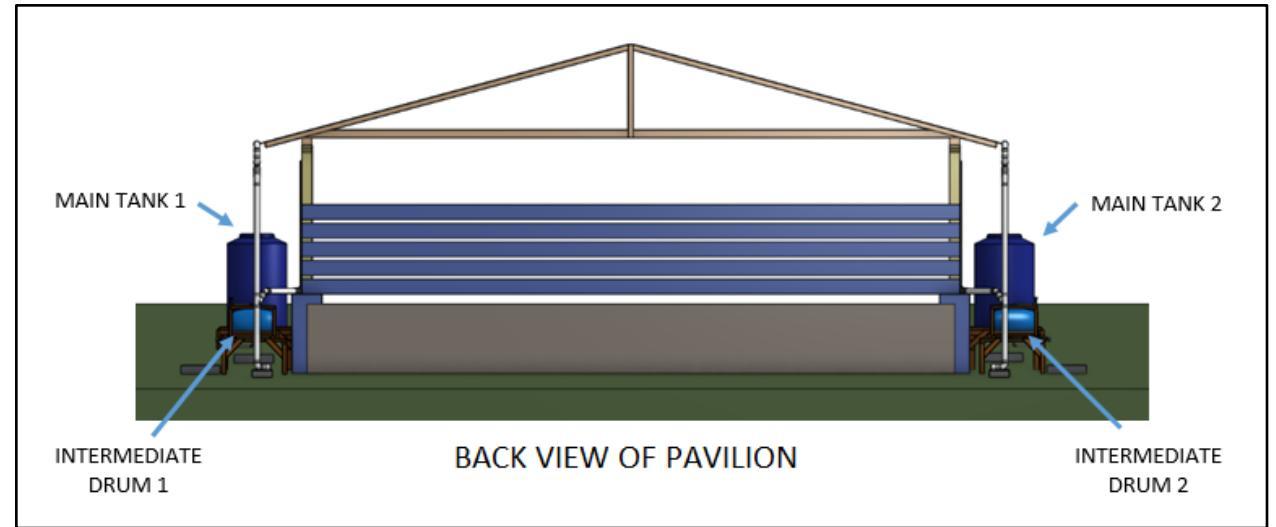
Figure C.1 - CAD drawing of testing locations on the pavilion

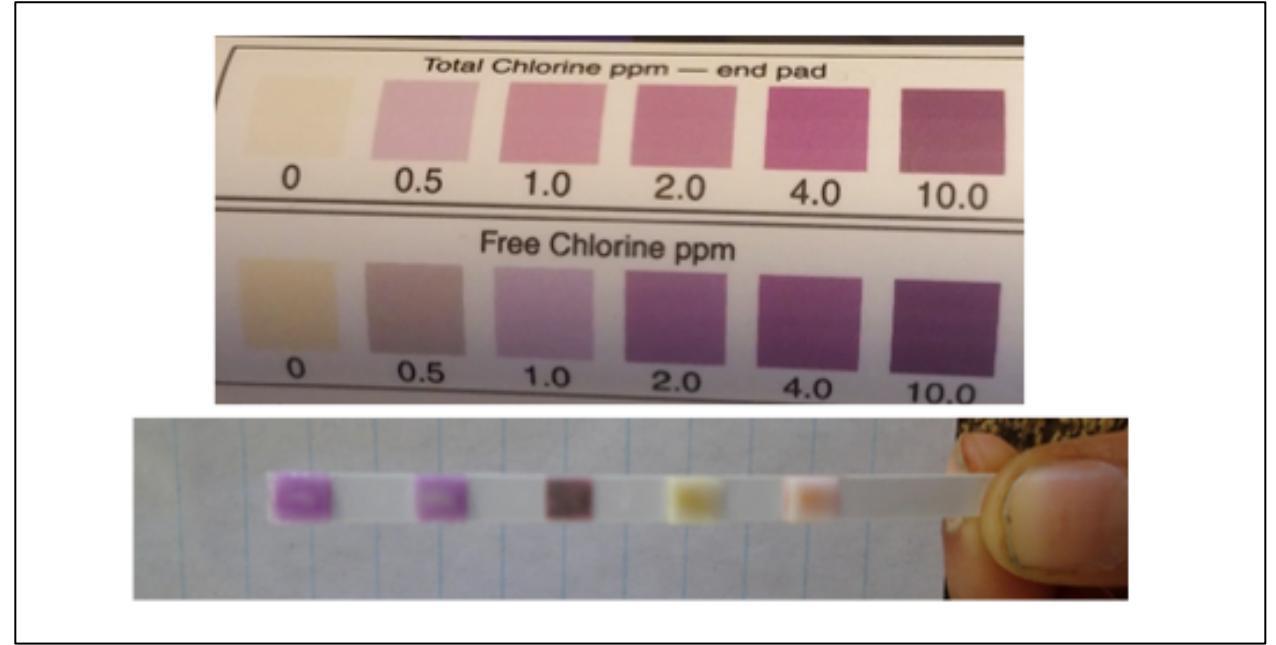
The chlorine residual ranged from 1 to 2 mg/L when a dosage of about 2.5 mg/L was applied. The residual is above the WHO recommended residual of 0.5 mg/L, and below the maximum concentration of 4 mg/L as recommended by the EPA. The pH level of the water was acceptable to use for chlorination.

Figure D.5.1 - Example strip after a chlorinated water test. The light pink/purple on the left indicate a range around 2.0 mg/L. The left most one is total while the second left is free chlorine.
